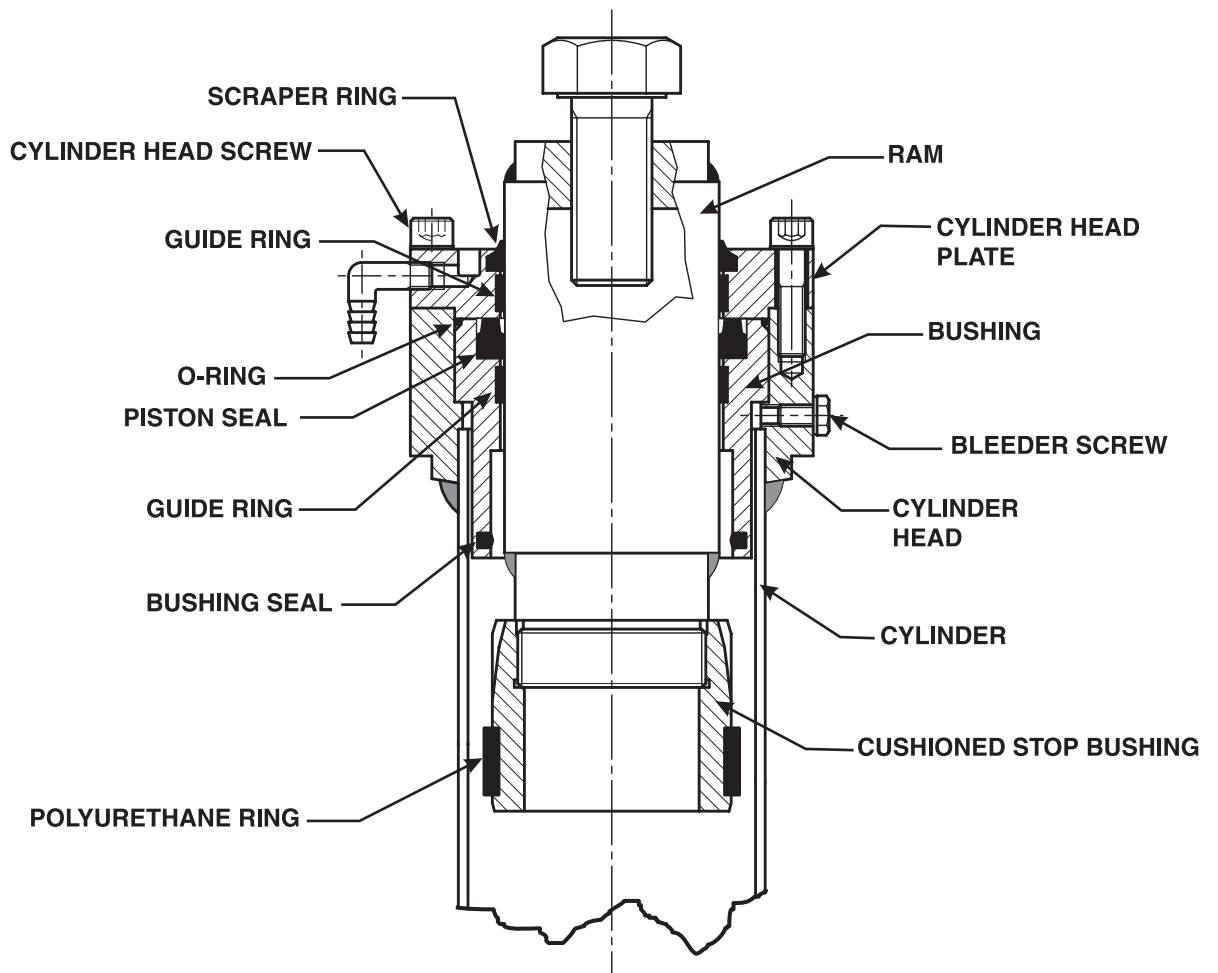
When you inspect the top end of the ram , secure the pulley in case of 2:1 installations , so that the ram can be further lowered and detached by at least 50 cm from the car or the pulley. Clean the upper part of the cylinder head thoroughly , inspect and smooth down the end part of the ram , loosen and take off the cylinder head screws , remove the cylinder head plate. Remove the scraper ring and the guide ring from the cylinder head plate.

Install a new gasket set and pay attention not to damage the inner lip of the piston seal.

Place the piston seal in the proper position with a wooden block.

The piston seal should be placed 2 - 3 mm from the edge of the bushing. The seal will be put in proper working position by tightening the cylinder head screws.
